# Manhole Inspection Summary

# Manhole # S09WW1012MH

Insp Date: **10/18/06 11:55 AM**

**Location** Address: **5504 WOODCREST AVE**

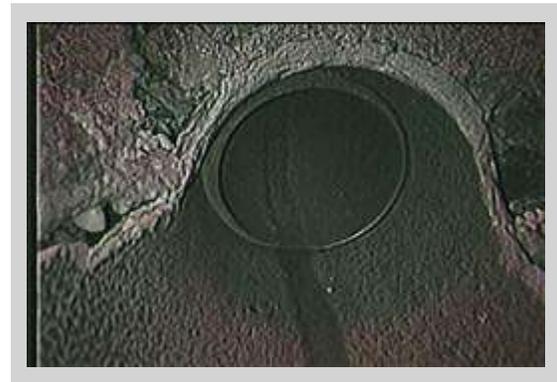
## Drop In @ 3 O'Clock

Drop: **Outside** Rod and Bar  
Angled: **Yes** Reading: **7.68** (ft.)  
Inv Depth: **8.68** (ft.)

Drop Condition: **Open**

Connects To: **House connection / Service line**

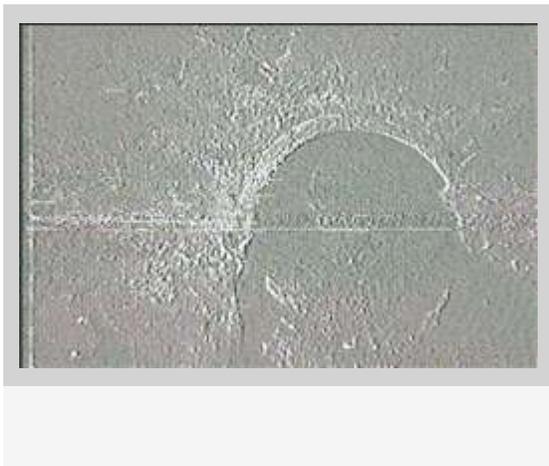
## 8 in. Circular Gravity Sewer

Infiltration: **None** Pipe Seal Cond: **Unknown**
